# Manhole Inspection Summary

Manhole # S31GG\_064MH

**Location** Address: **HOWARD ST**

Cross Street: **PARK AVE**

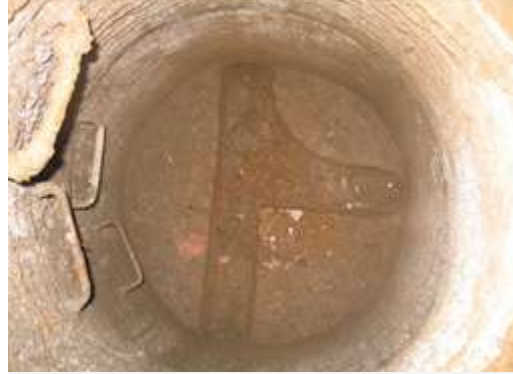
Top View

Bench and Channel debris. Corroded steps.

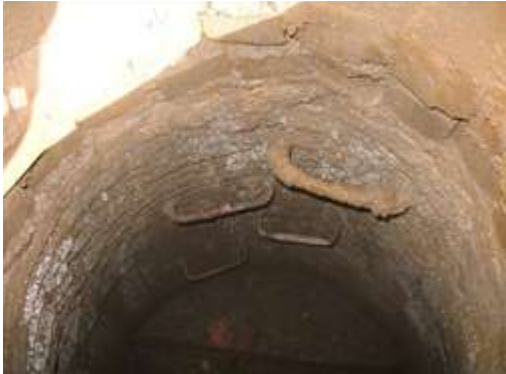
Defect

Frame leaks. Adjustment deterioration and infiltration. Corbel and Barrel infiltration - other side.

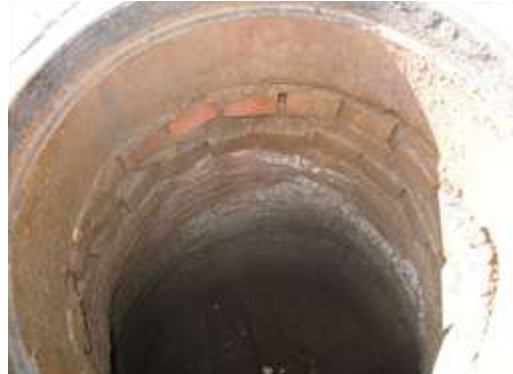
Defect

Frame leaks. Adjustment deterioration and infiltration. Corbel and Barrel infiltration.

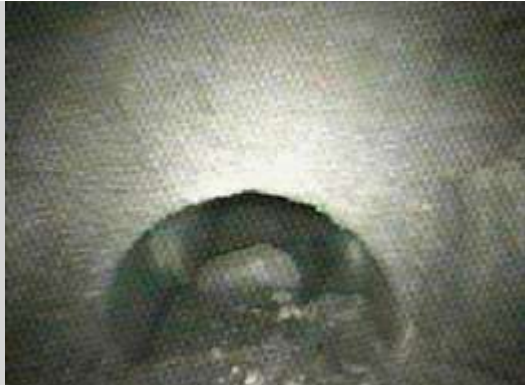
### 8 in. Circular Gravity Sewer Pipe Out @ 12 O'Clock

Deposits: ☐ None ☒ **Mud** ☐ Sludge ☒ **Debris** ☐ Grease

Silt Depth: **2** (in.) Deposits Extent: **Medium**

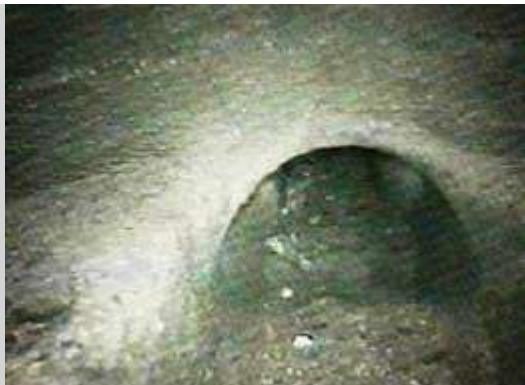
### 8 in. Circular Gravity Sewer Pipe In @ 3 O'Clock

Deposits: ☐ None ☒ **Mud** ☐ Sludge ☒ **Debris** ☐ Grease

Silt Depth: **2** (in.) Deposits Extent: **Medium**

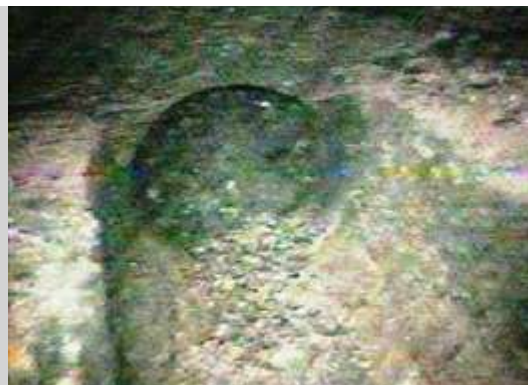
Pipe In @ 6 O'Clock

Infiltration: **Evidence**

Connects To: **Stub connection / abandoned**
